Subject: Final Report--Giant Garter Snake Study

Results of Relocating Canal Habitat of the :
Giant Garter Snake (Thamnophis gigas) During the
Widening of State Route 99/70 in
Sacramento and Sutter Counties, California

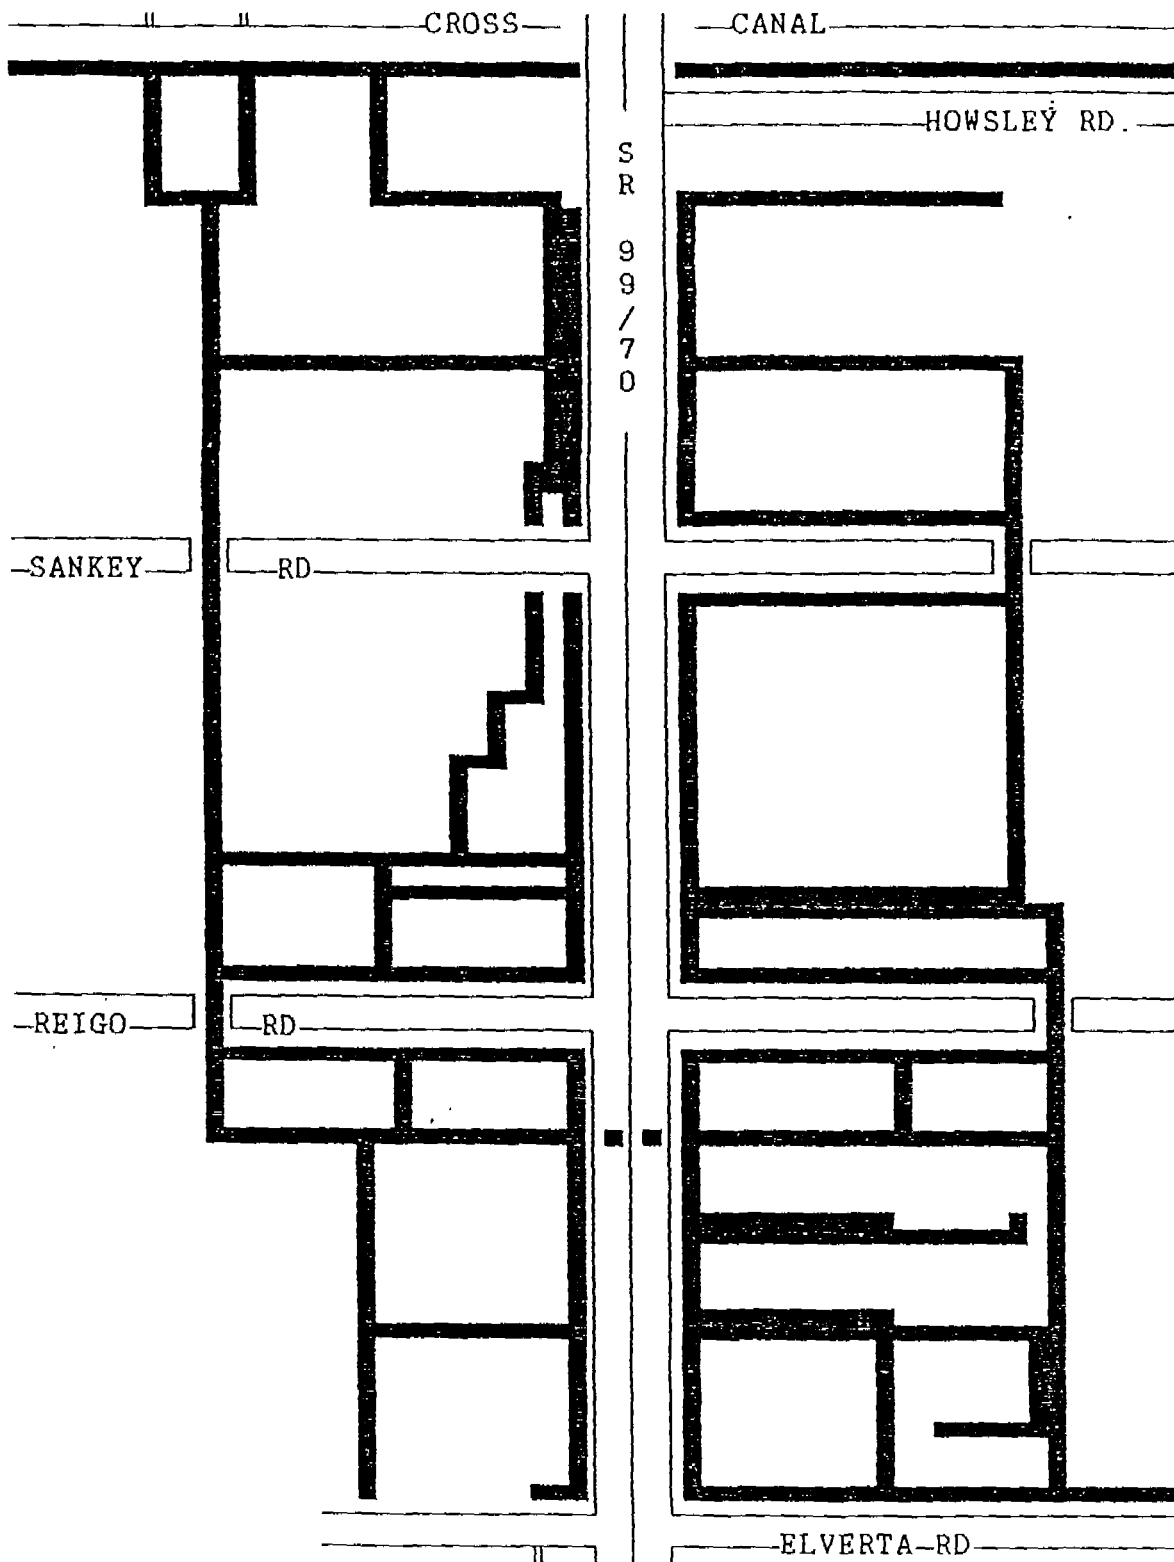
Figure 2. Pre-Construction Distribution of GGS Canal/Ditch Habitat During 1988 (Shown shaded

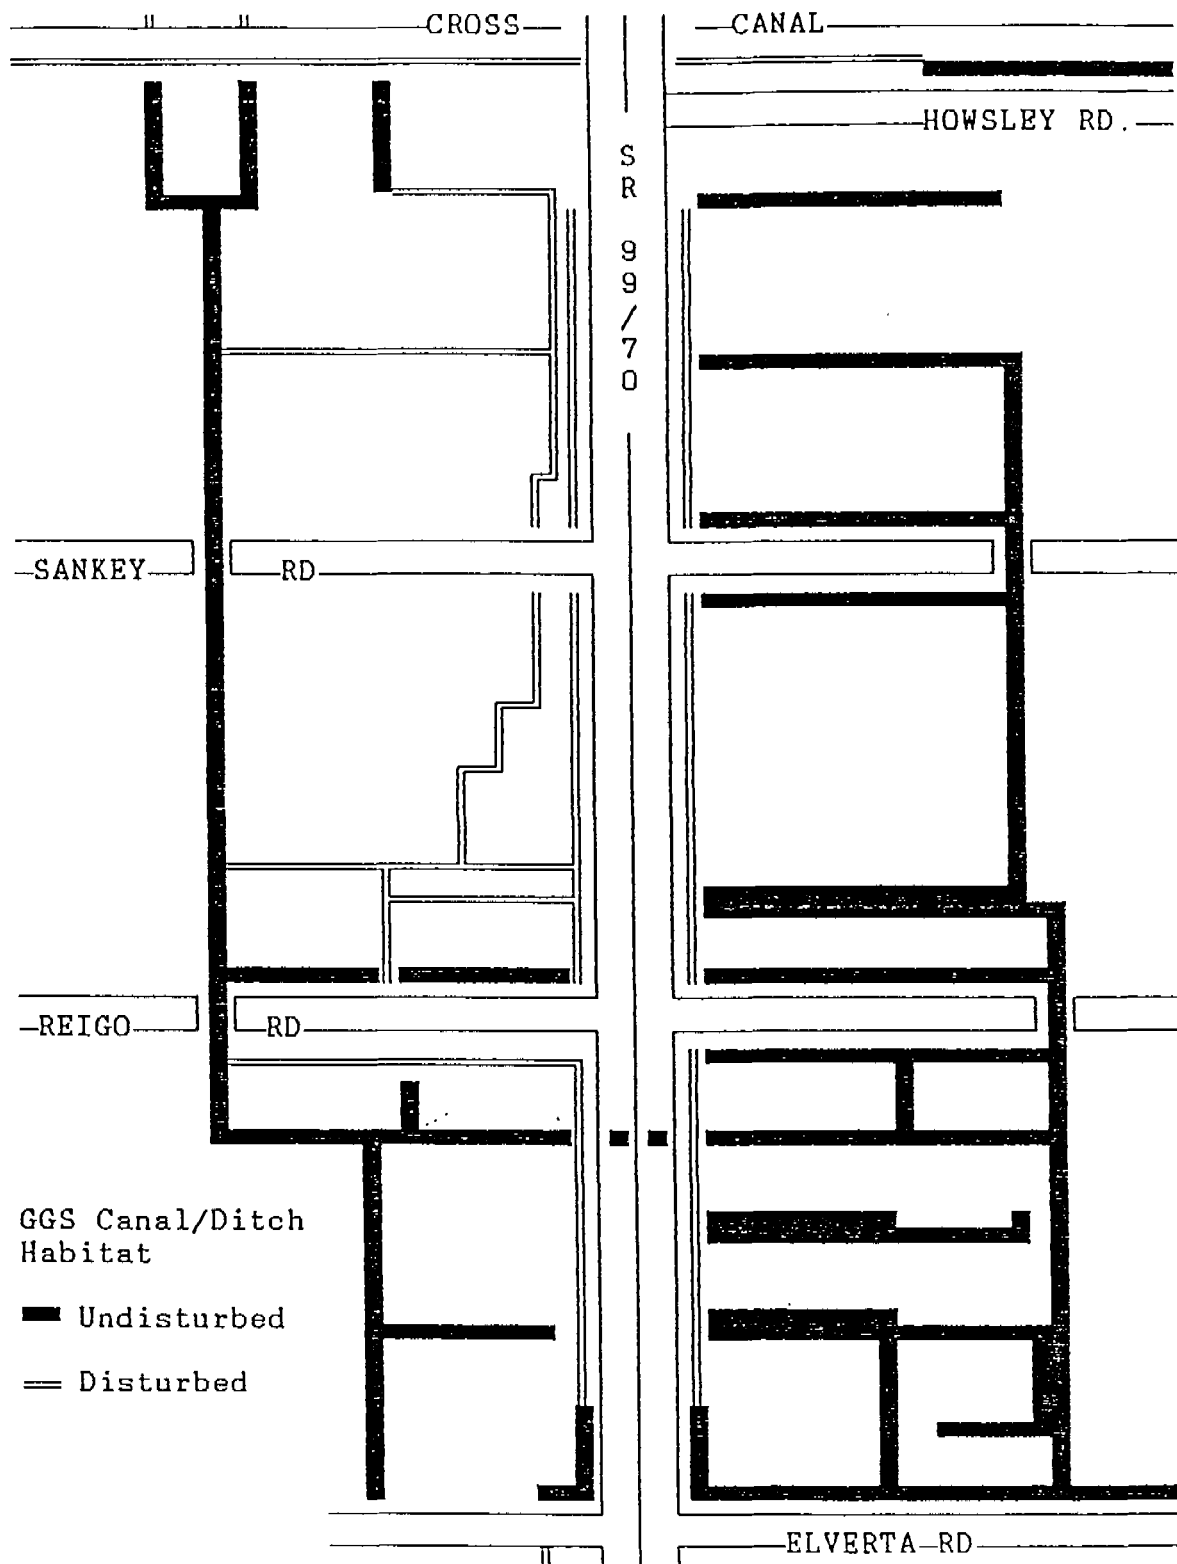
Figure 3. Post-Construction Distribution of GGS Canal/Ditch Habitat (1991).

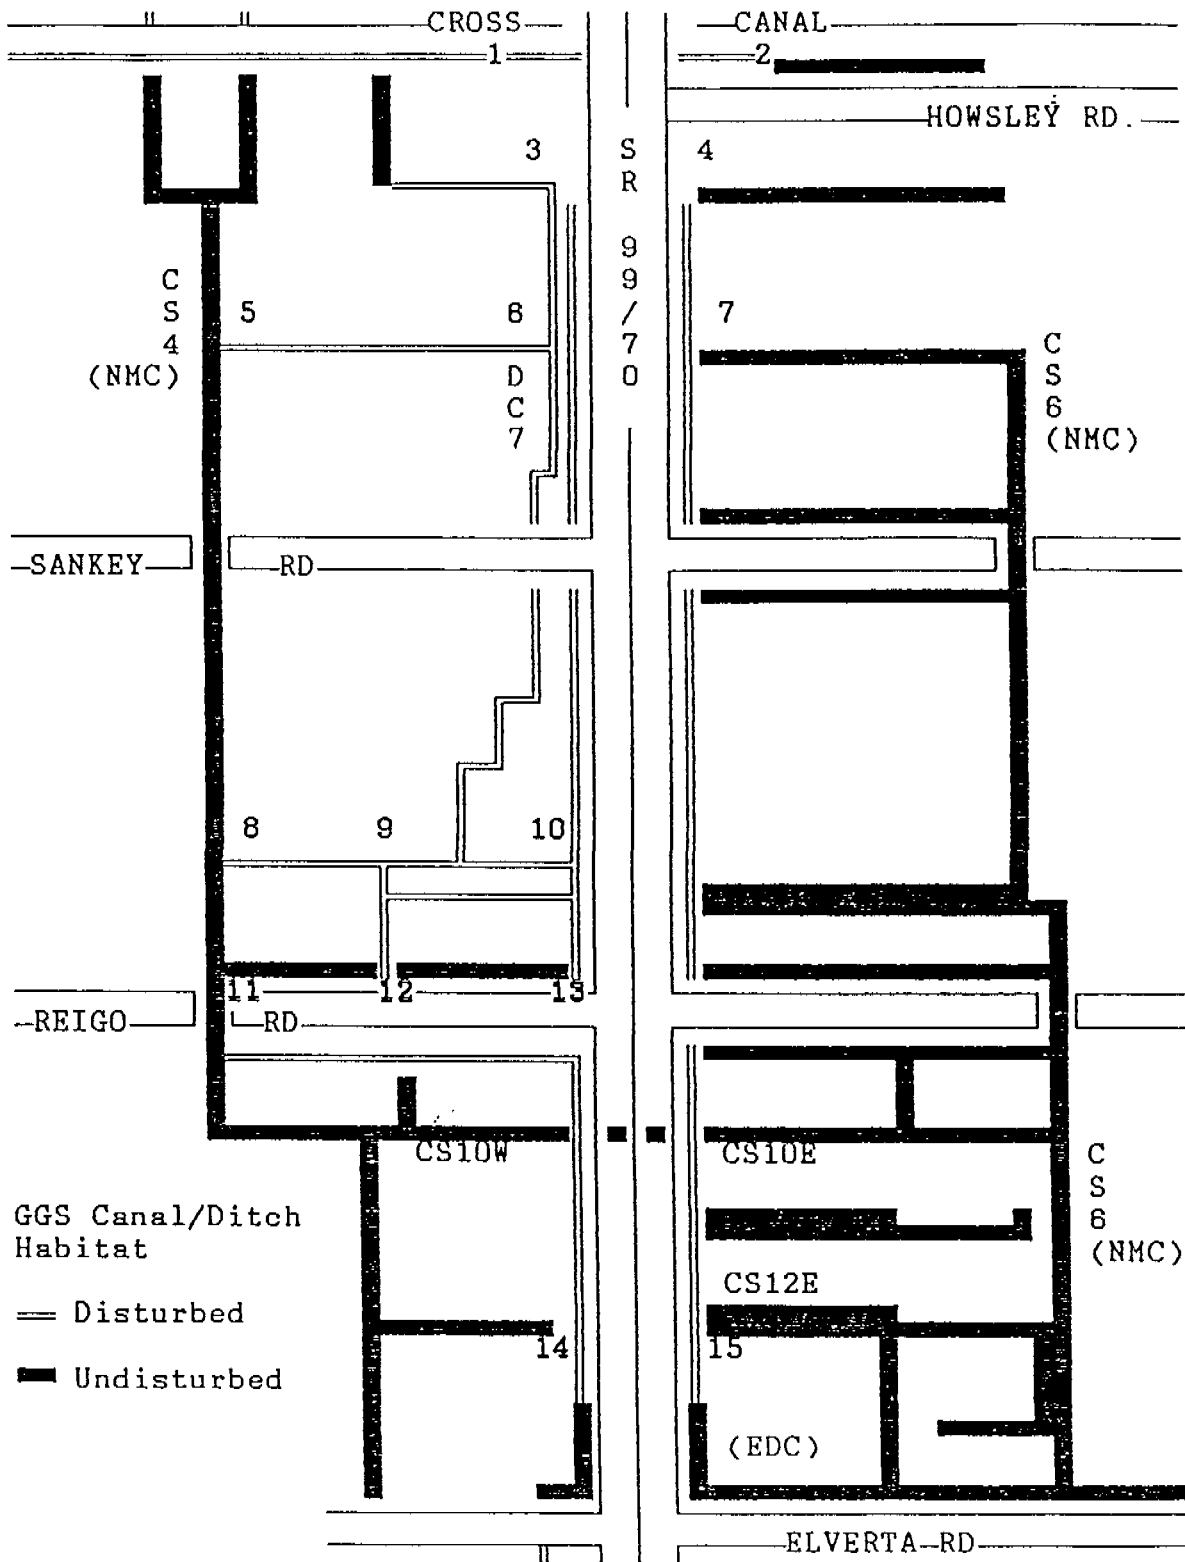
Figure 4. Locations of GGS Photo Stations and Major Project Features.

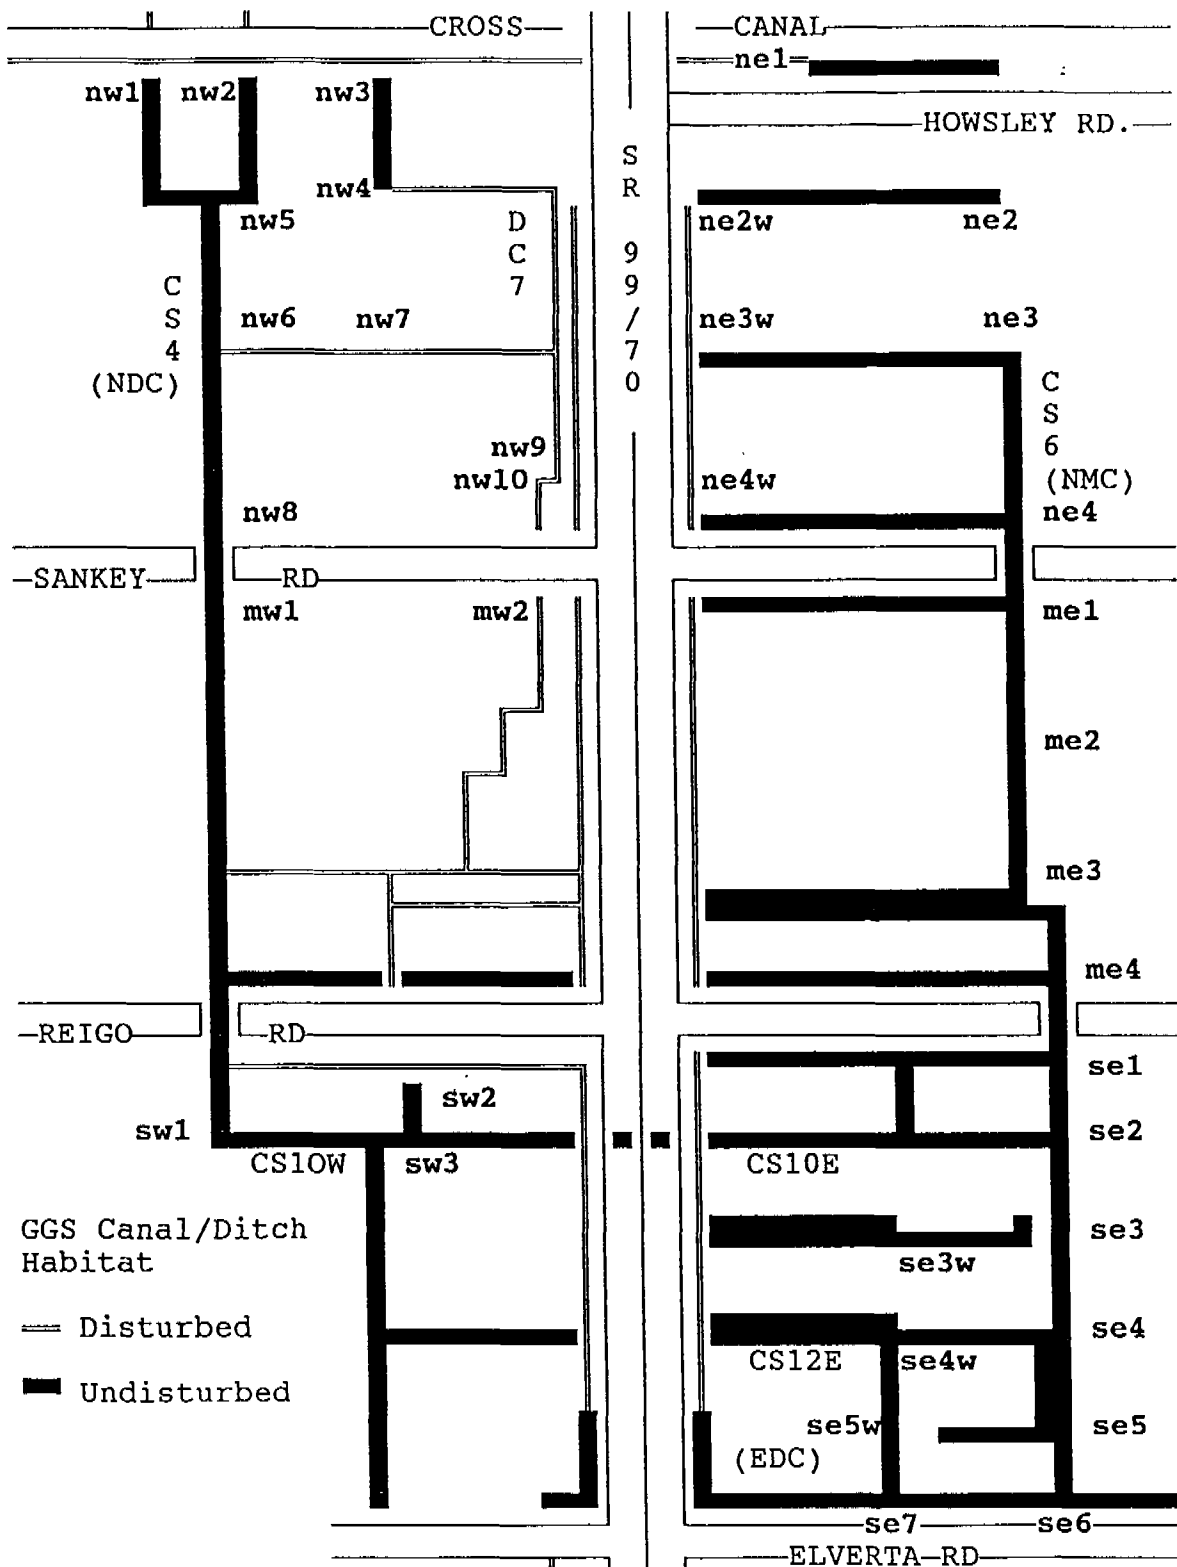
Figure 5. Locations of GGS Sample Stations and Major Project Features.

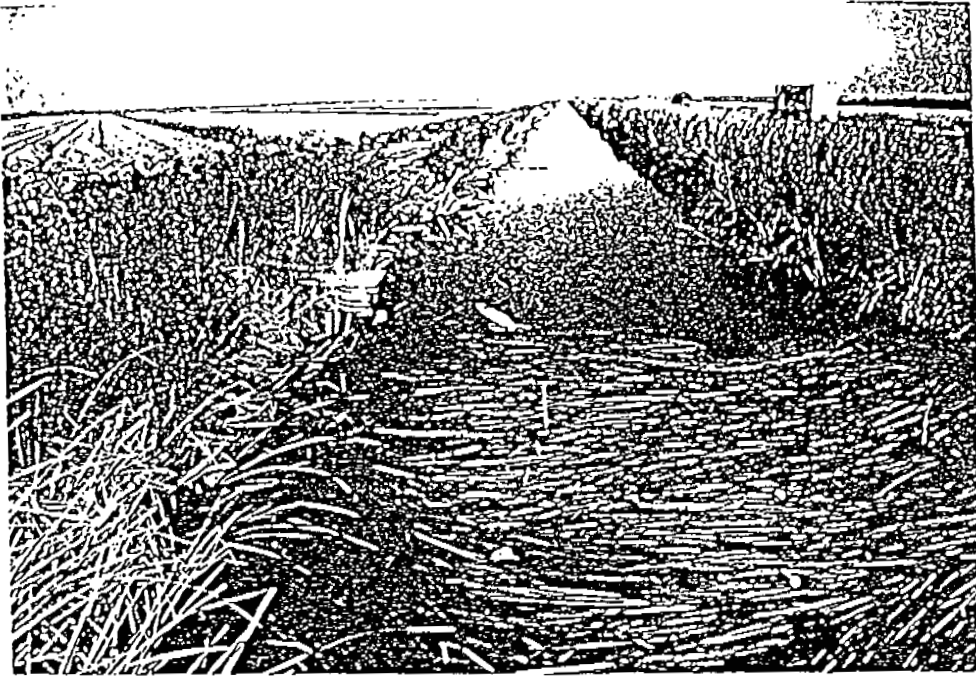
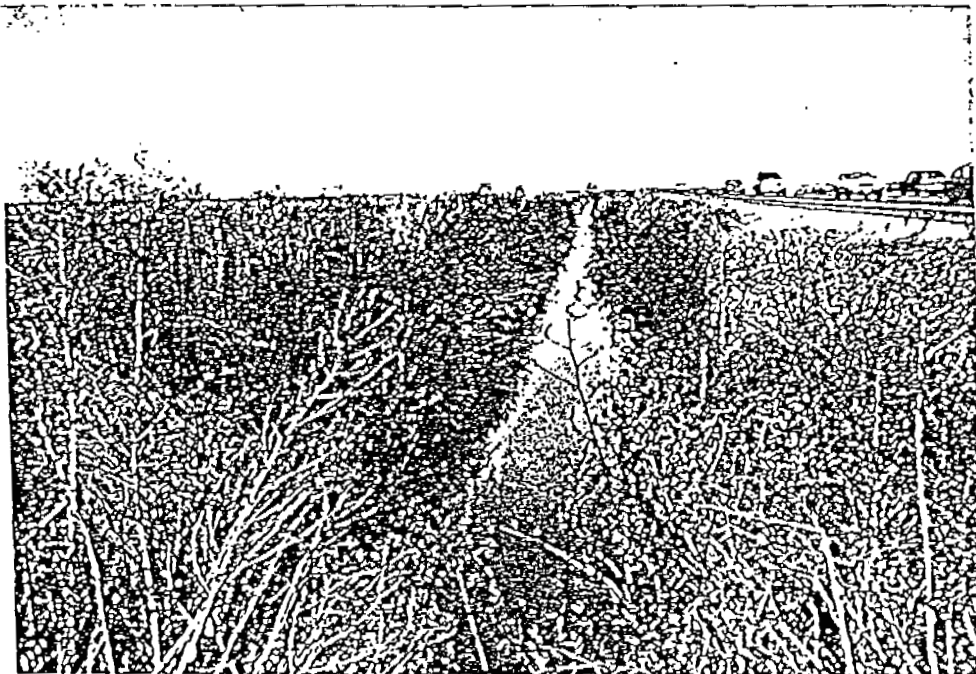
Figure 6. Pre-construction canal habitat of the GGS adjacent to State Route 99/70. (A) DC-7, looking north from Photo Station 6, July 1988; (B) DC-7, looking north from sample station NW-10, July 1988. Photos by George E. Hansen.

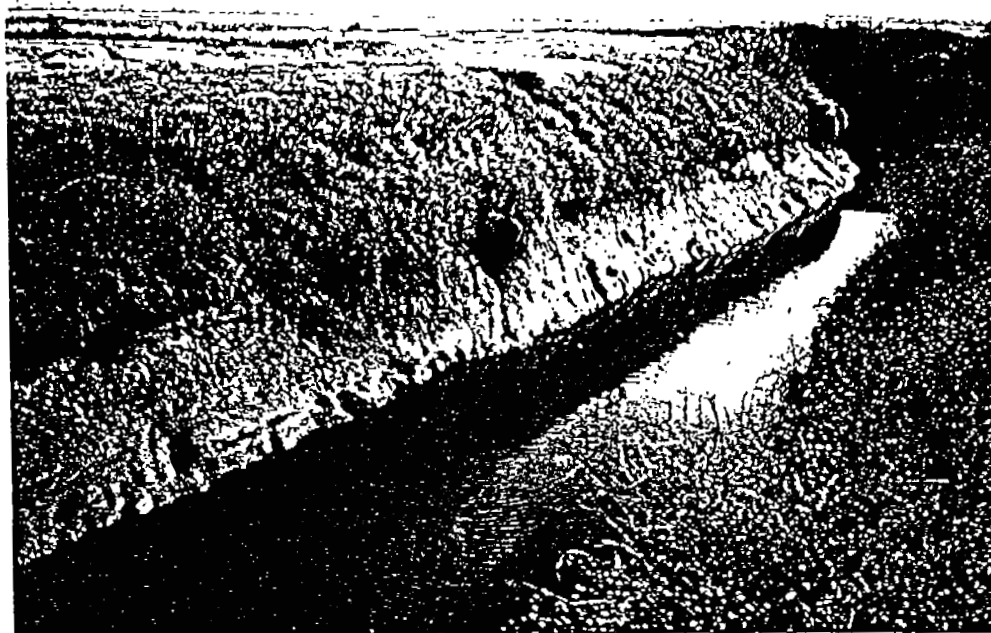
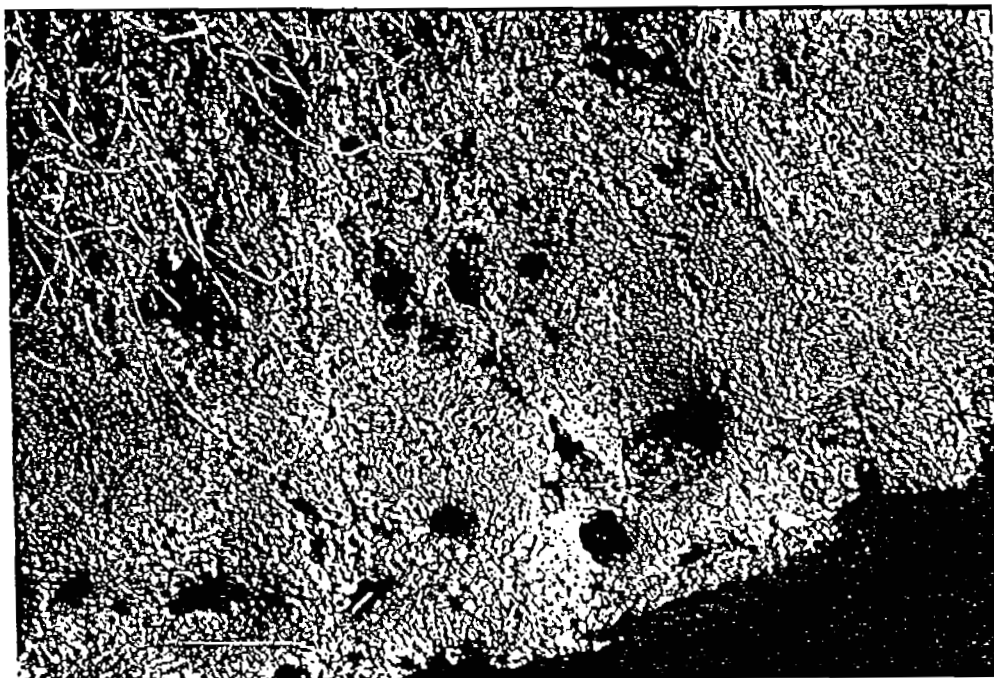
Figure 8. Undisturbed canal showing holes in the banks utilized by GGS. (A) CS-4, looking south from SW-1, November 1989; (B) same area showing close-up of holes exposed during low water, November 1989. Photos by George E. Hansen.

Substrate. The banks of those canals that supported aggregations of GGS were riddled with cracks, rodent burrows and crayfish burrows which GGS were frequently observed entering and exiting (Figure 8).

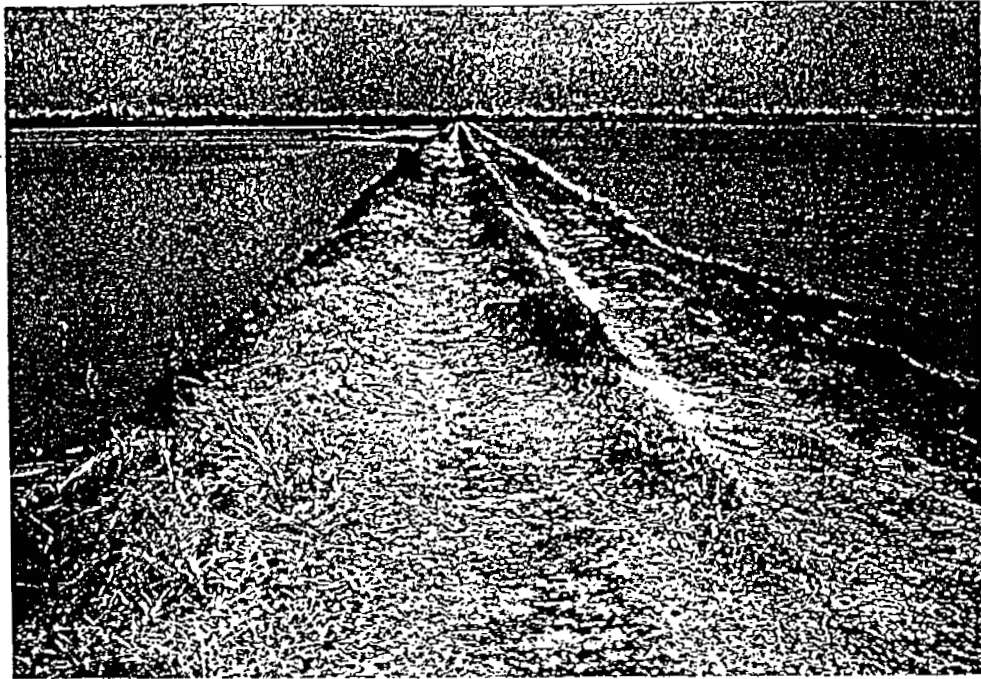
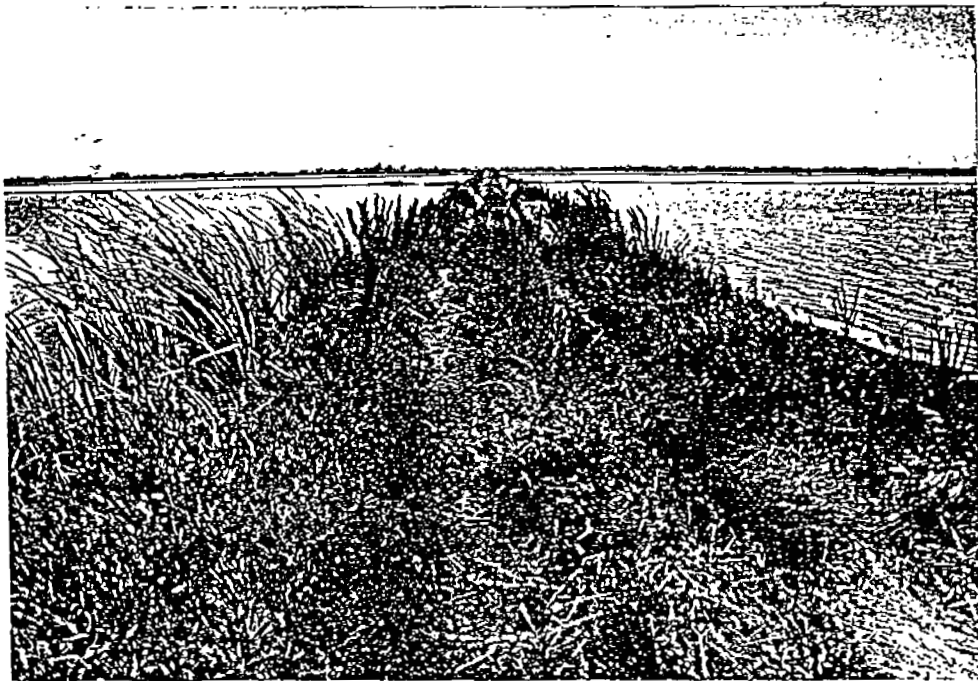
Figure 9. Rice fields in study area during spring flooding. (A) SE-5, looking west from a point west of CS-6, prior to vegetation growth, May 1991; (B) SE-4/5, looking west from a point west of CS-6, showing vegetation growth along rice field berm (access road), May, 1991. Photos by George E. Hansen.

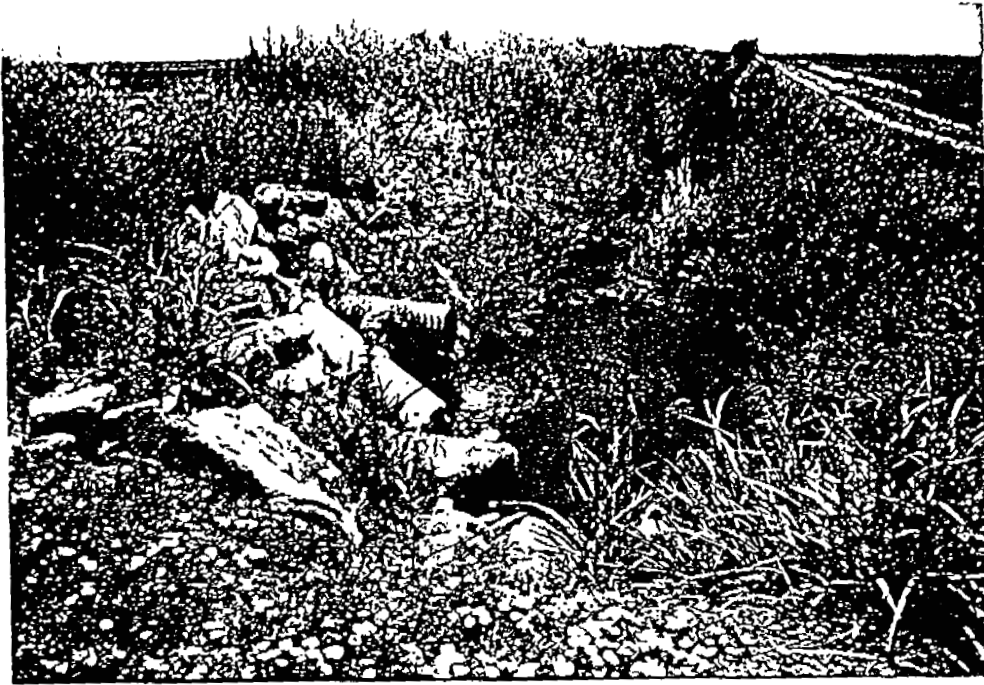
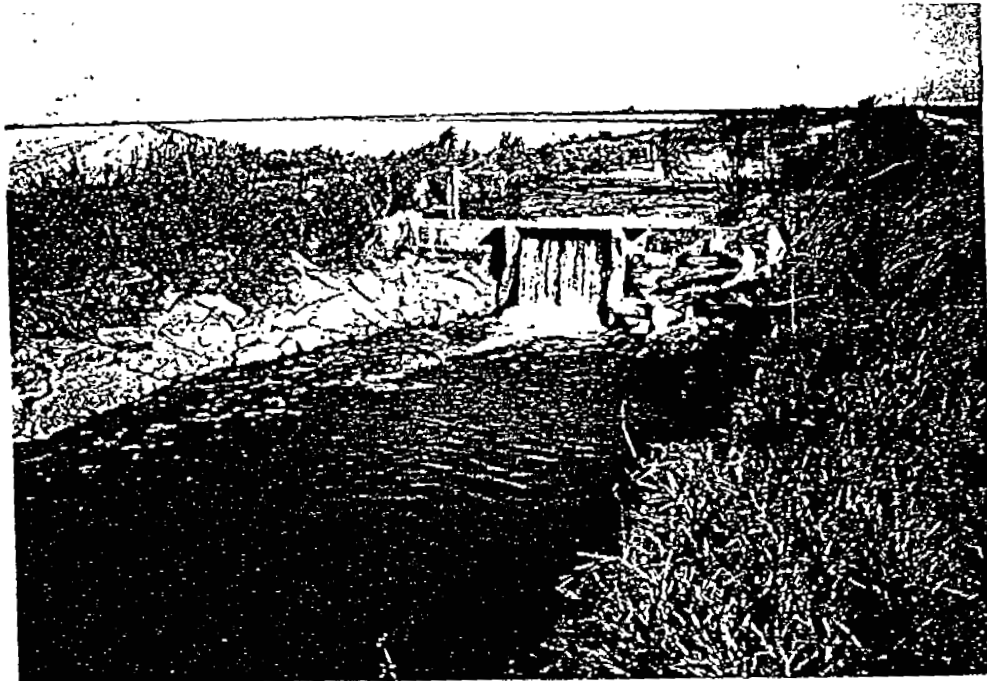
Figure 10. Two examples of "outfall pools" that form at the culverts and check dams along the study area waterways, note the rip-rap placed around the structures. (A) CS-12E looking west from SE-4W, July 1990; (B) CS-6 at SE-3N, looking north west, fall 1987. Photos by George E. Hansen.

Structures. Prior to canal reconstruction, check dams, culvert headwalls, and associated rip-rapped banks provided cover for the GGS. Water entering a canal in the vicinity of these structures usually eroded an "outfall pool" where persistent water supported aquatic prey prior to drying completely (Figure 10). Rip-rap (broken pieces of concrete from culverts, drain pipes, roadways, and other structures) had usually been added to the canal banks at these locations to slow erosion.

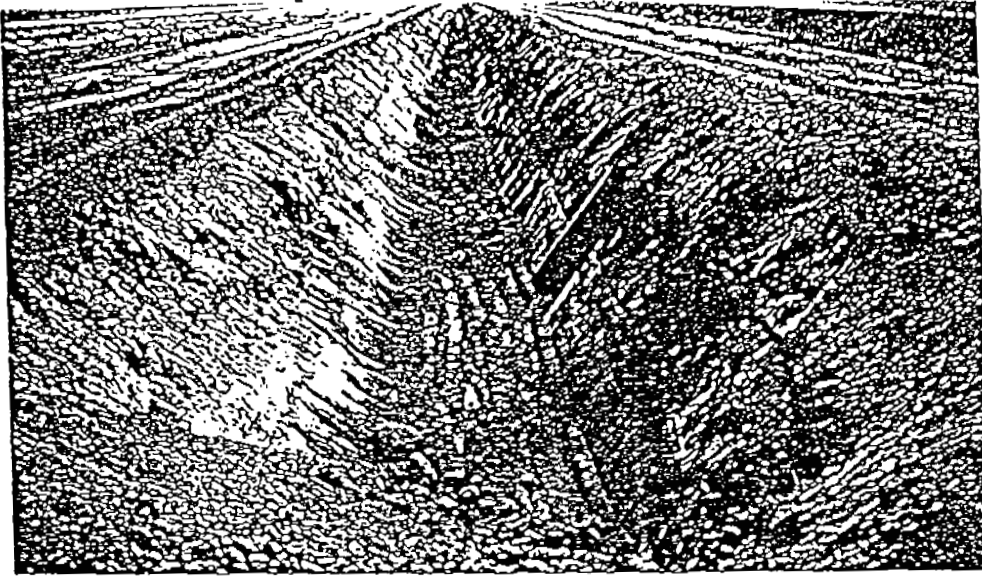
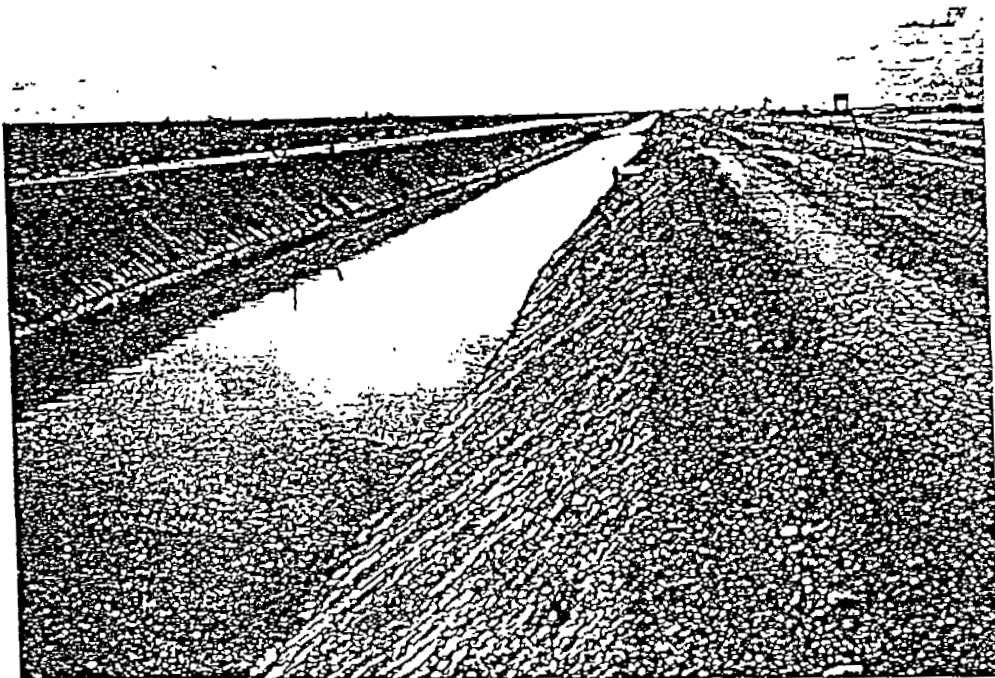
Figure 11. Newly constructed canals in the GGS study area. Note the compacted banks and berms. (A) DC-7, looking south from Photo Station 3, April 1988; (B) East Drainage Canal, looking south from Photo Station 15, July 1988. Photos by George E. Hansen.

and the area was graded. New canals (DC's) were either excavated below the level of the surrounding land or were created by building up berms to contain them above the level of the surrounding land. In both cases the banks were then compacted and graded uniformly. At completion, no vegetation or burrows existed along the new DC's (Figure 11).

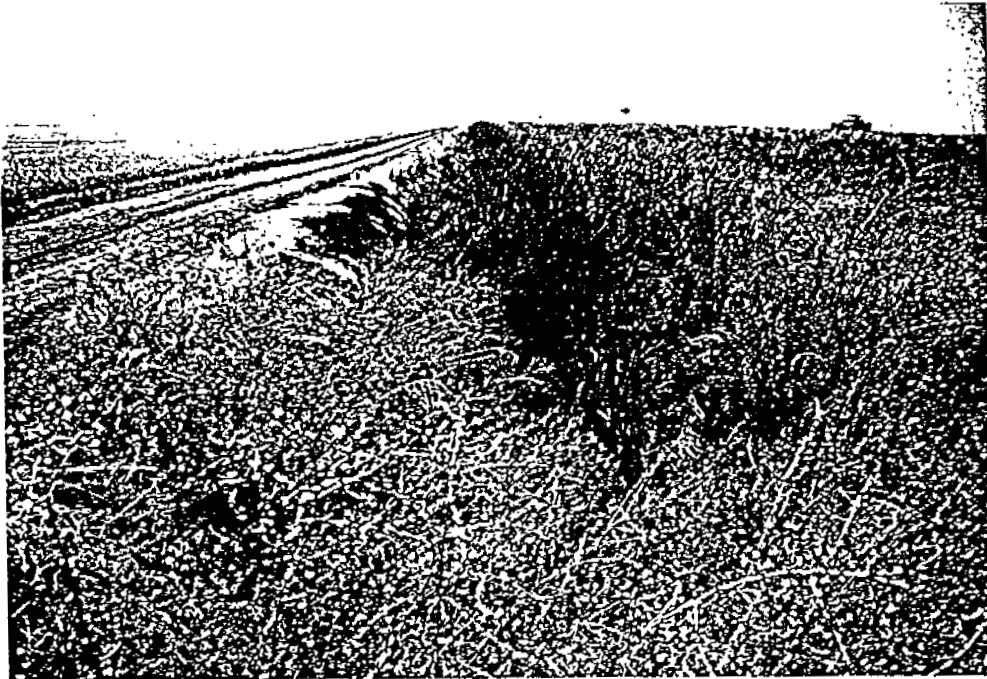
Figure 12. Recovering vegetation along one of the study area disturbed ditches, looking south from Photo Station 7, September 1989. Photo by George E. Hansen.

Vegetation. Drought conditions that persisted through February 1989 slowed habitat recovery along the new berms and banks of the DC's. Revegetation finally began as above normal precipitation fell during March 1989 and encouraged a belated spring growth of mustard, thistles and grasses on the disturbed banks and berms of the DC's (Figure 12).

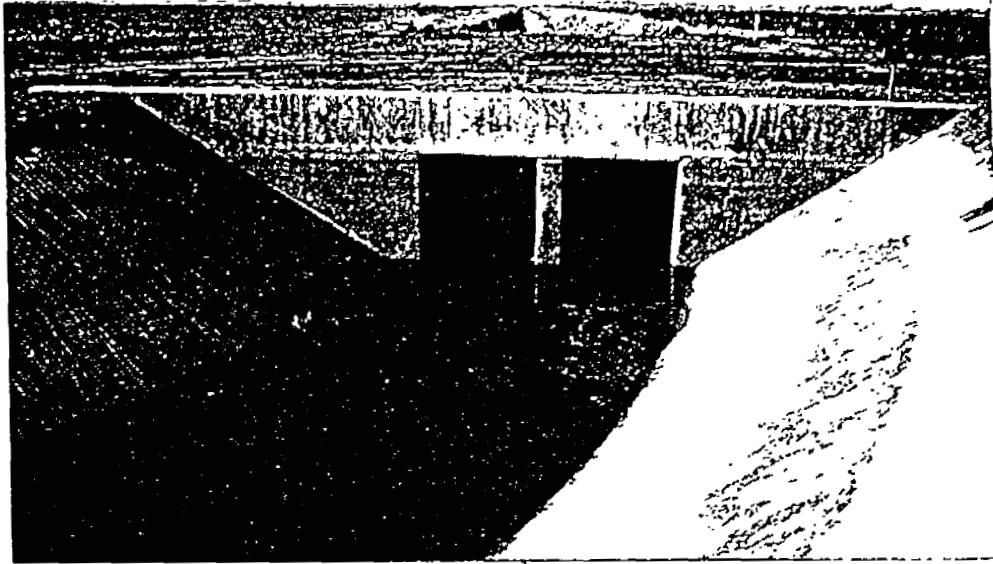
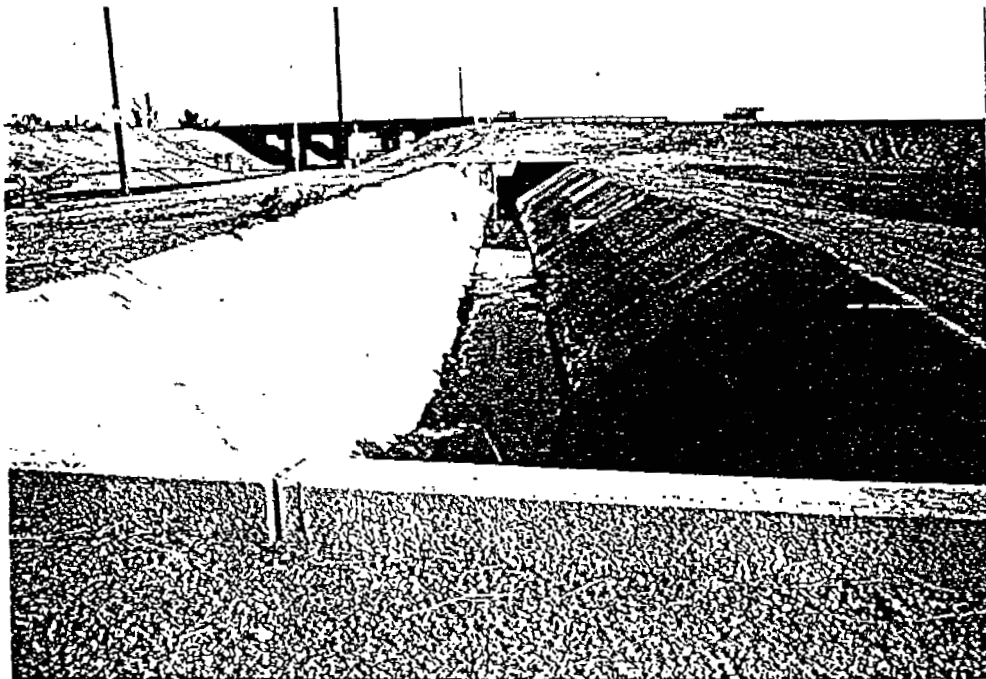
Figure 14. Concrete structures along one of the new canals in the study area. These structures provide no habitat or shelter for the GGS. (A) CS-3W, looking west from Photo Station 3, February 1990; (B) CS-1W, looking east from Photo Station 1, December 1990. Photos by George E. Hansen.

Structures. New concrete check dams, culvert headwalls, and concrete canal linings (Howsley Road at SR 99/70) were designed and constructed as solid structures that when new provide no shelter for GGS (Figure 14). These will probably crack, erode, or be excavated by burrowing animals in time, but will probably never replace the original structures and their accompanying rip-rap in GGS habitat value.

The newly constructed check dams, culverts, and culvert headwalls were poured as solid concrete structures. These have failed to provide the sheltering maze of corridors found within the rip-rap, old check dams, and accompanying vegetation that they replaced. Concrete lined channels, such as those constructed east and west of SR 99/70 at Howsley Road, extended these detrimental effects along substantial lengths of canals, making them inhospitable traps where any GGS that inadvertently wandered into them would be exposed to predators. Again, the expected replacement/recovery of protective cover did not occur.

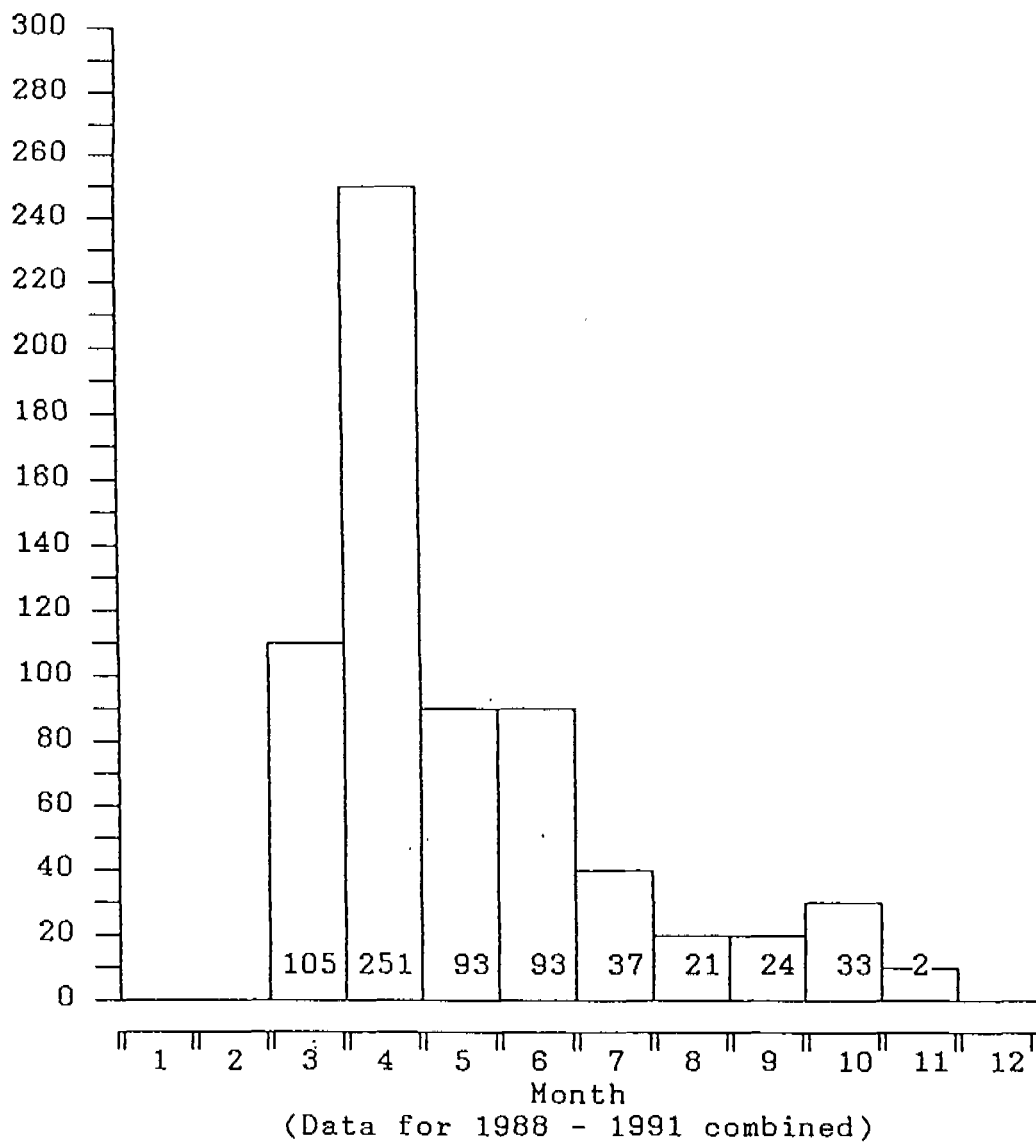
Figure 15. GGS sighted per month for 1988-1991 combined (n=659).

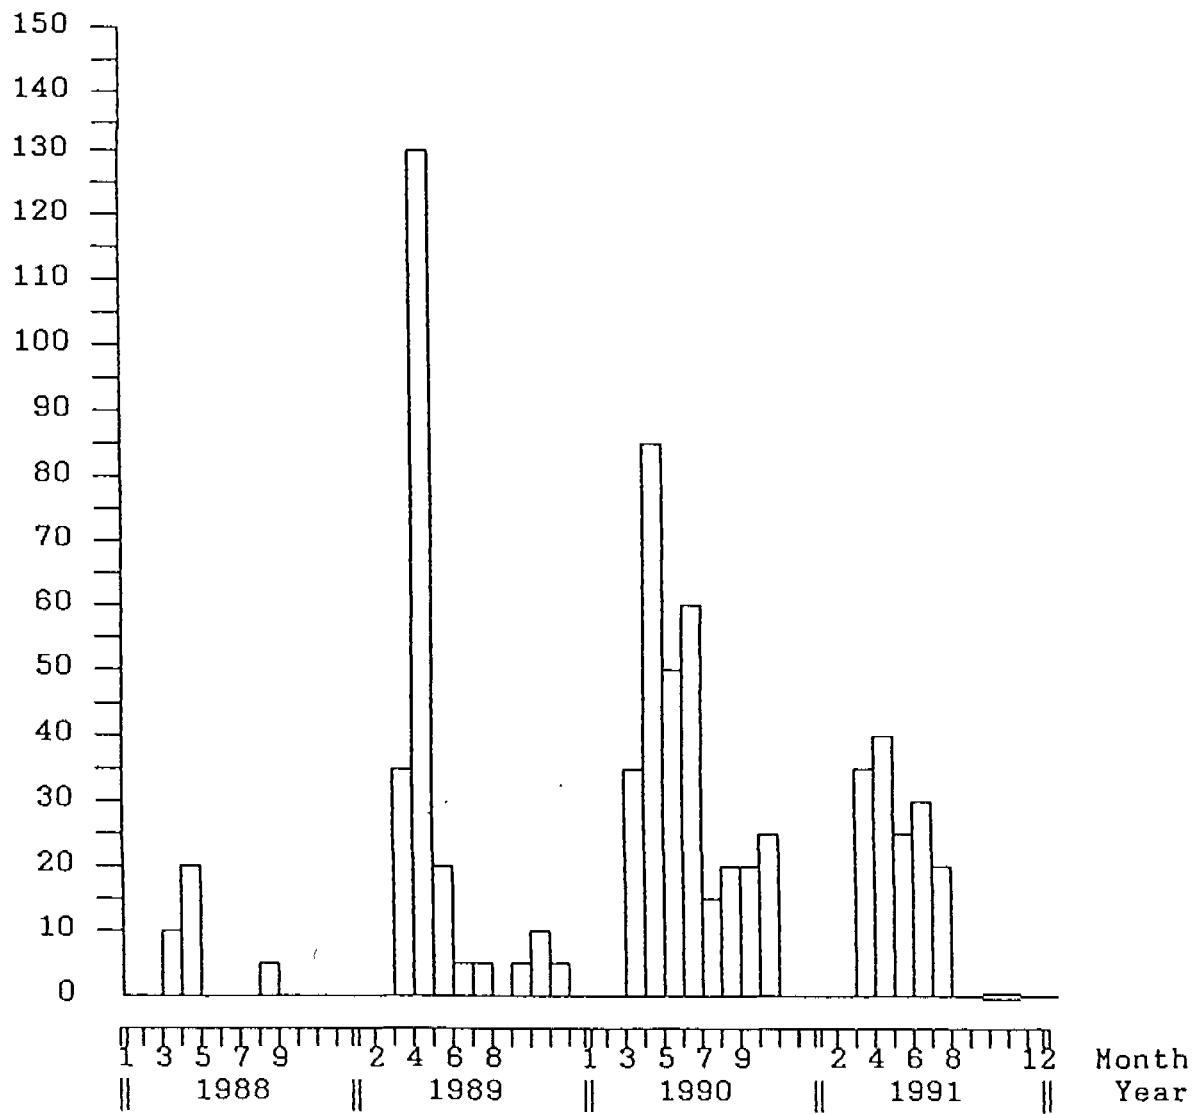
Figure 16. GGS sighted near study area per month (n=682).

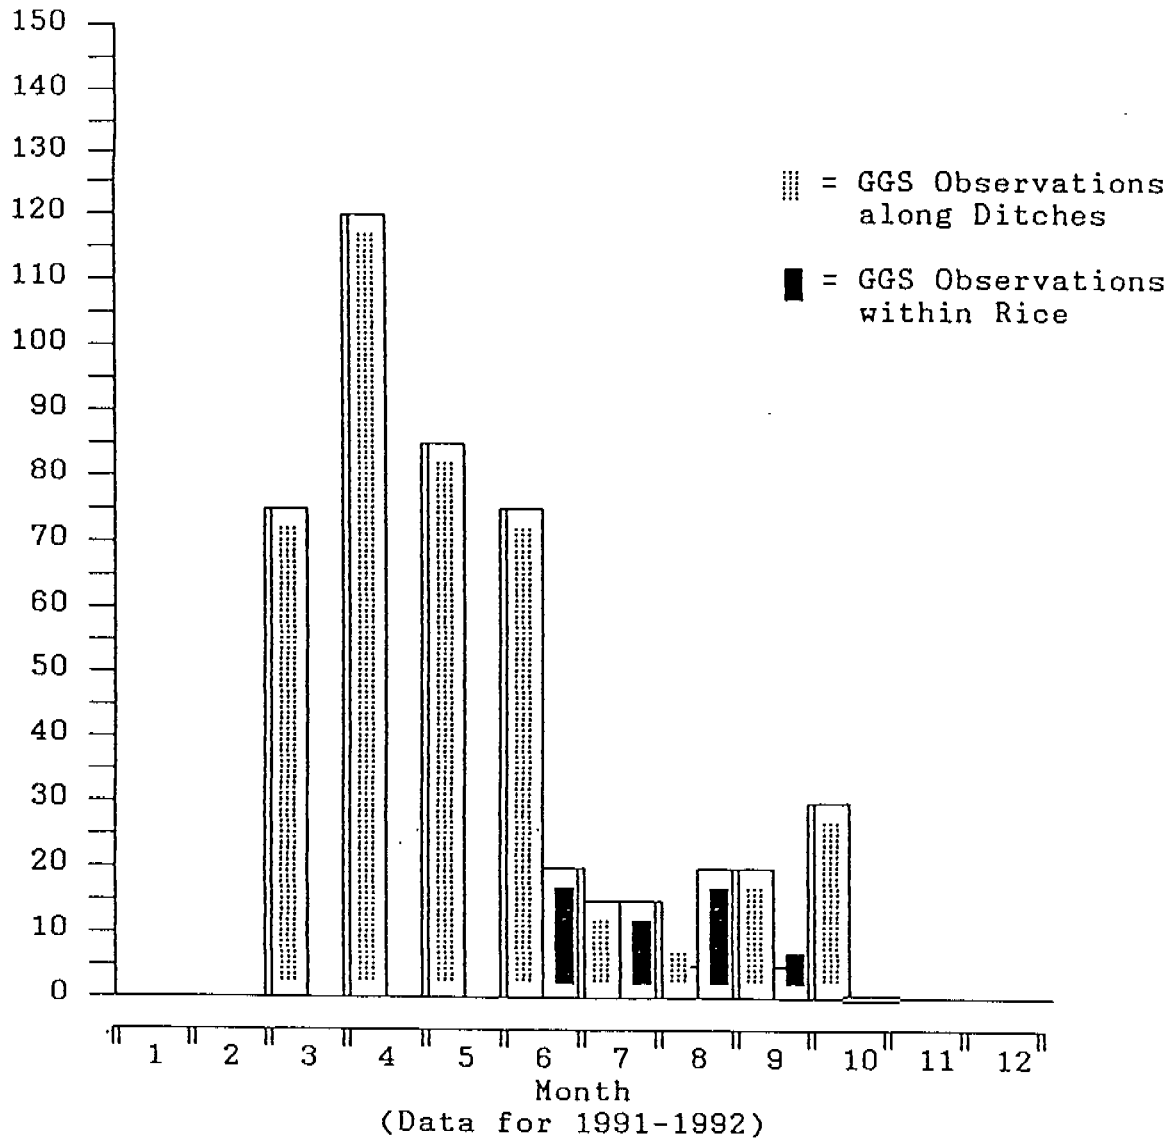
Figure 17. Seasonal occurrence of GGS within ditches and rice fields during 1991-1992.

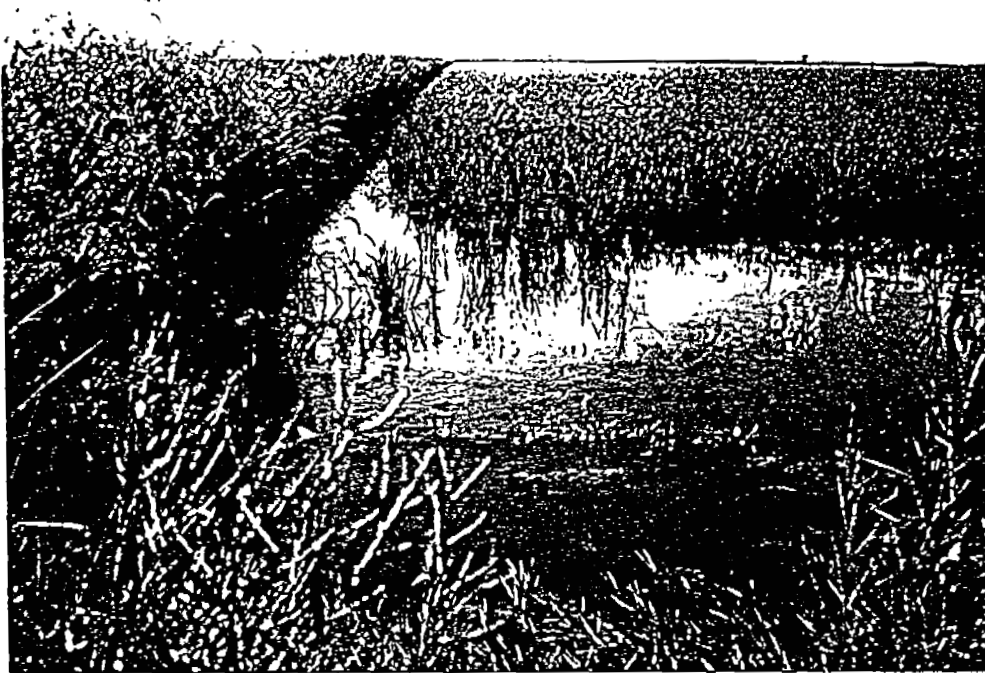
Figure 18. A rice field in late summer, showing the GGS cover provided by the densely vegetated berm and rice plants, west of CS-6 at SE-4, looking southwest, August 1990. Photo by George E. Hansen.

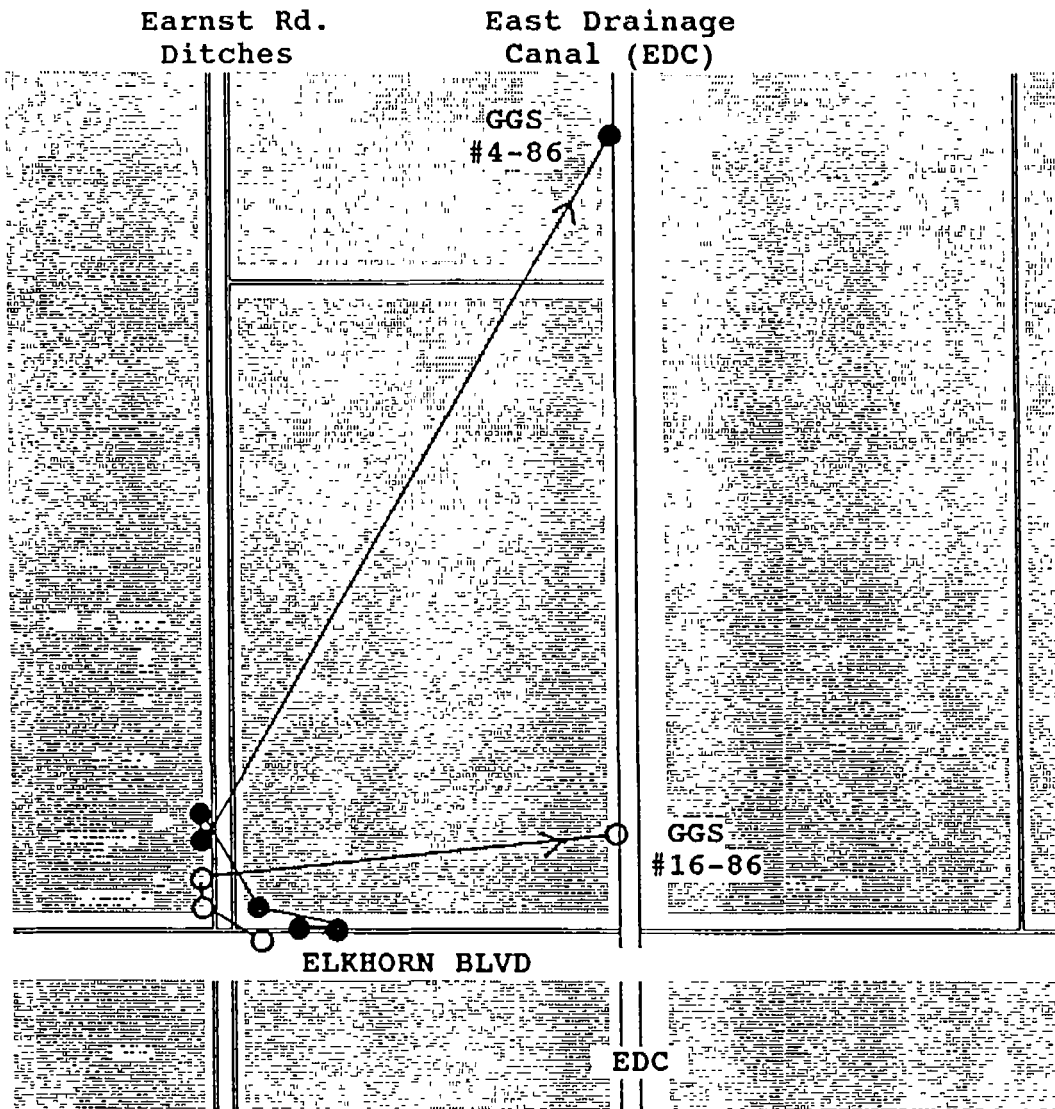
GGs MOVEMENT (arrow shows direction of movement, but does not indicate route taken.)

Figure 19. Movements of Two GGS Based on Recaptures Between March 1986 and June 1987.
