Subject: Final Report--Giant Garter Snake Study

Results of Relocating Canal Habitat of the :
Giant Garter Snake (Thamnophis gigas) During the
Widening of State Route 99/70 in
Sacramento and Sutter Counties, California

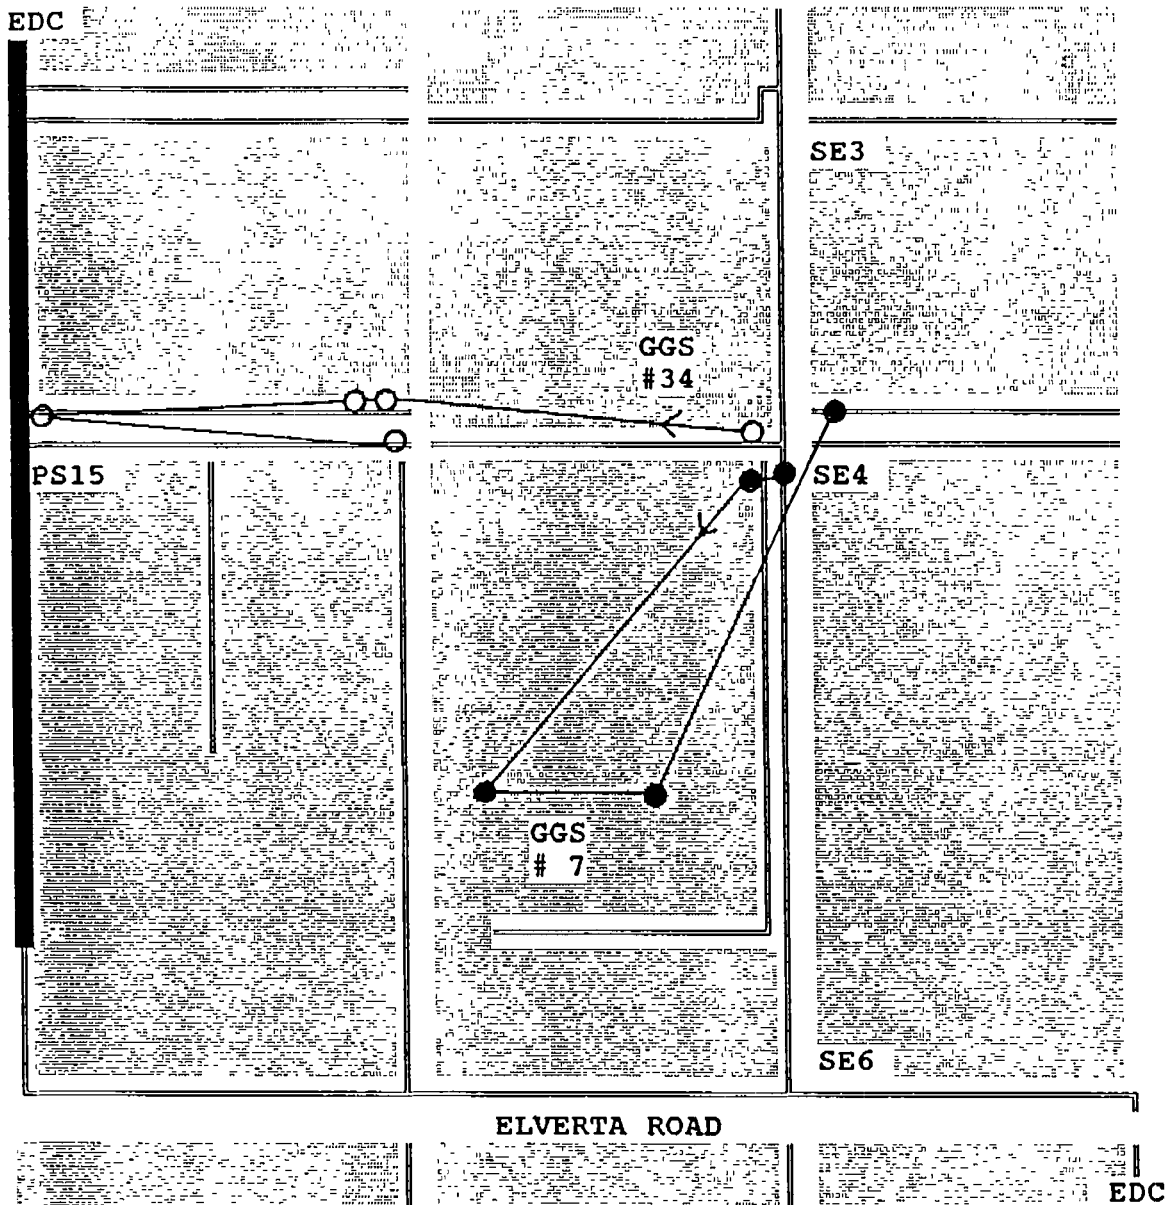
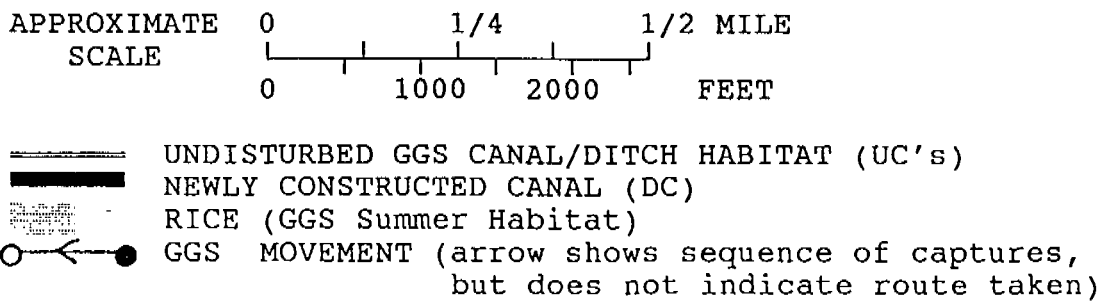
Figure 20. Movements of Two GGS Based on Recaptures Between April 1989 and October 1992.

During this study, GGS were observed to readily relocate distances of over one mile along project UC's, and GGS were observed to routinely move from one project UC to another. GGS were observed to move along the smaller connecting UC's, and several were seen to approach the edge of the unvegetated EDC without entering. For example, adult female GGS #34 was captured and recaptured at five locations along one mile of the undisturbed CS-12E between April 10, 1989 and October 11, 1992 (Figure 20). This female was among three GGS encountered at the intersection of CS-12E and the EDC on October 9, 1992; and that had fled from the east bank of the EDC into CS-12E when approached. When GGS #34 was returned to her capture point at the EDC/SC-12E intersection the following day (October 10, 1992), she fled into CS-12E as had her two companions the day before. GGS #34 was next recaptured 1/2-mile east at SE 4W on October 11, 1992, illustrating a movement of 1/2 mile away from the EDC in one day.
